**Flood Control Project Maintenance  
Levee Inspections**

## Maintenance Issue Types Only, Levee Inspection Report By Mile - Spring 2015

### Reclamation District No. 2064 River Junction

Waterway	Bank	Unit Miles	Inspection Start/End	Inspector
Unit No. 01 San Joaquin River	Right	5.56	04/21/2015 04/21/2015	Herman Phillips

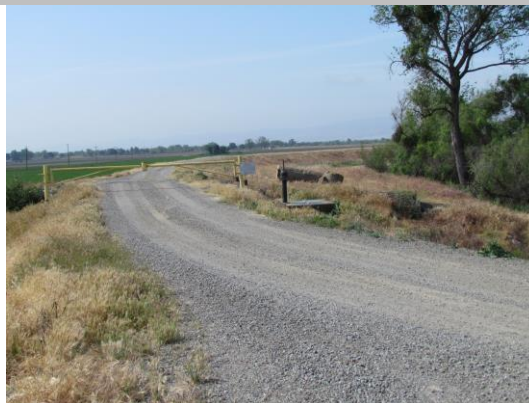
Photo 1 of 1 : SP\_2015\_RD2064\_313\_22\_20150604\_00009.jpg

LM Start	0.05	Rating **	M	Issue No.	22
LM End	0.68	Issue Type +	Ma	Location *	LS
Category	Earthen Levee			GPS Latitude/Longitude	
				Start	End
Item	Vegetation			37.709850 °	37.702112 °
				-121.267578 °	-121.271432 °
DWR ID	DWR_RD2064_01_s _ 2015_22				
Action/Comments					
Control annual grass and weeds on the levee slopes and easements.

View looking downstream along the landside slope.

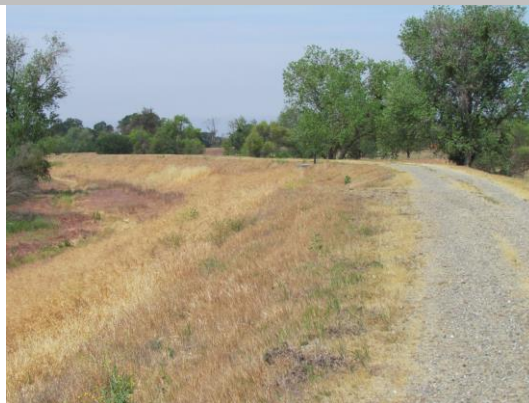
Photo 1 of 1 : SP\_2015\_RD2064\_313\_26\_20150604\_00010.jpg

LM Start	1.59	Rating **	U	Issue No.	26
LM End	1.65	Issue Type +	Ma	Location *	WS
Category	Earthen Levee			GPS Latitude/Longitude	
				Start	End
Item	Vegetation			37.690678 °	37.690067 °
				-121.270525 °	-121.269865 °
DWR ID	DWR_RD2064_01_s _ 2015_26				
Action/Comments					
Remove the wild growth other than native grasses from the levee slopes.					
Inspector Comments: Control the unacceptable weeds on the waterside levee slope.

View looking downstream at unacceptable weeds on the levee slope.

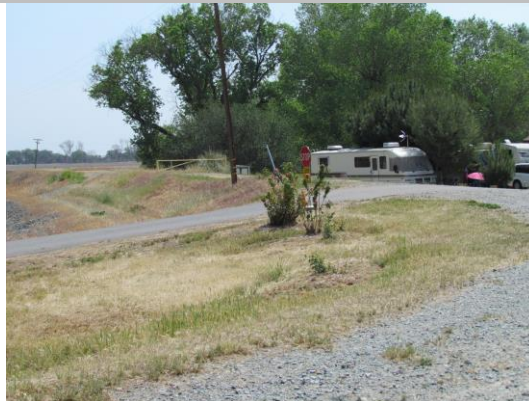
Photo 1 of 1 : SP\_2015\_RD2064\_314\_2\_20150604\_00014.jpg

LM Start	0.00	Rating **	M	Issue No.	2
LM End	5.89	Issue Type +	Ma	Location *	LS
Category	Earthen Levee			GPS Latitude/Longitude	
				Start	End
Item	Vegetation			37.667068 °	37.704049 °
				-121.240899 °	-121.181042 °
DWR ID	DWR_RD2064_02_s _ 2012_2				
Action/Comments					
Control annual grass and weeds on the levee slopes and easements.

View looking downstream at the landside slope.
